August 30, 2007
Project 04516-2

Geotechnical
Environmental and
Water Resources
Engineering

Re: **Monthly Remedial Monitoring Report No. 4**
50 Tufts Street Site
Somerville, MA
RTN 3-23246

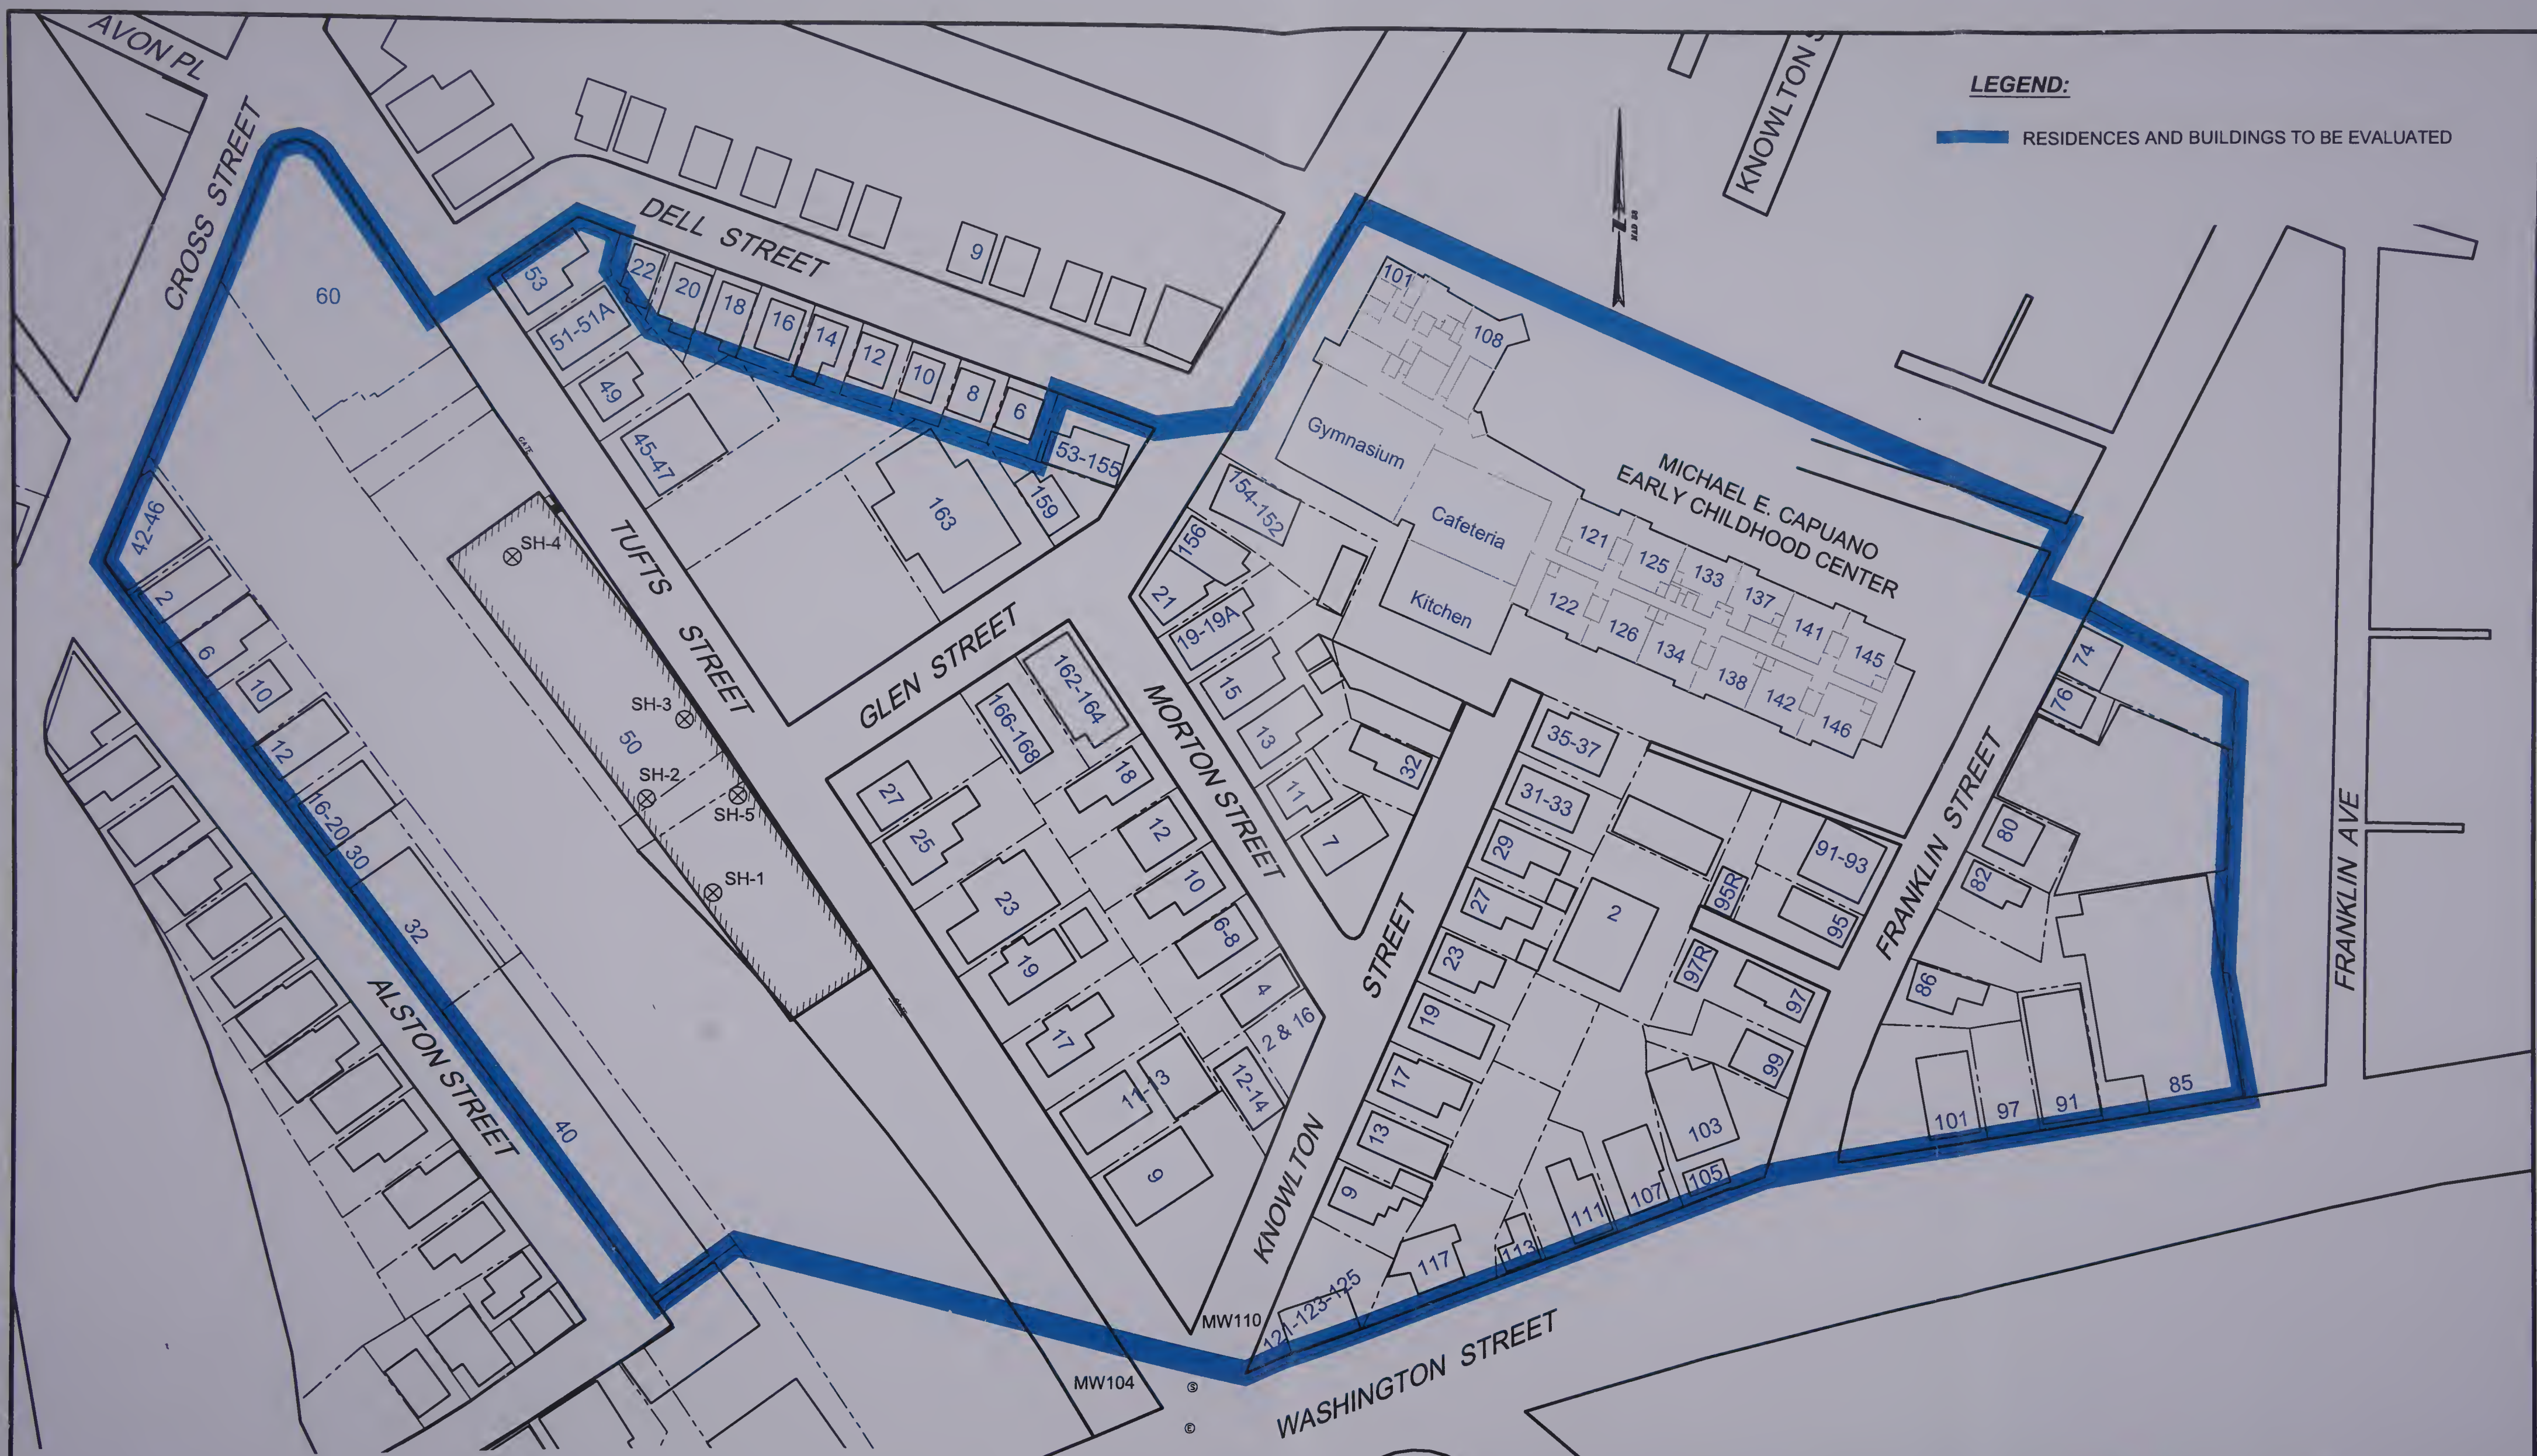
Fig. 2

On behalf of UniFirst Corporation (UniFirst) of Wilmington, Massachusetts, GEI Consultants, Inc. is submitting this Remedial Monitoring Report (RMR) No. 4 for the operation of Active Remedial Systems related to the release of chlorinated volatile organic compounds (VOCs) at 50 Tufts Street in Somerville, Massachusetts (Site), Figure 1. The Massachusetts Department of Environmental Protection (DEP) initially assigned Release Tracking Number (RTN) 3-26114 to the release. The Site was later incorporated into the nearby site at 50 Tufts Street (RTN 3-23246) and on July 21, 2007, the RTNs were linked. A sub-slab depressurization system (SSDS) was installed and began operating at the Michael E. Capuano Early Childhood Center (Center) located at 150 Glen Street in Somerville, Massachusetts (see Figure 2) on February 1, 2007 in order to mitigate chlorinated VOCs detected in indoor air at the Center. Residential SSDSs were installed in May and June 2007 at 23 Tufts Street, 31-33 Knowlton Street, 95 Franklin Street and 95R Franklin Street. An additional residential SSDS was installed at 18 Morton Street on July 9, 2007 (see Figure 2).

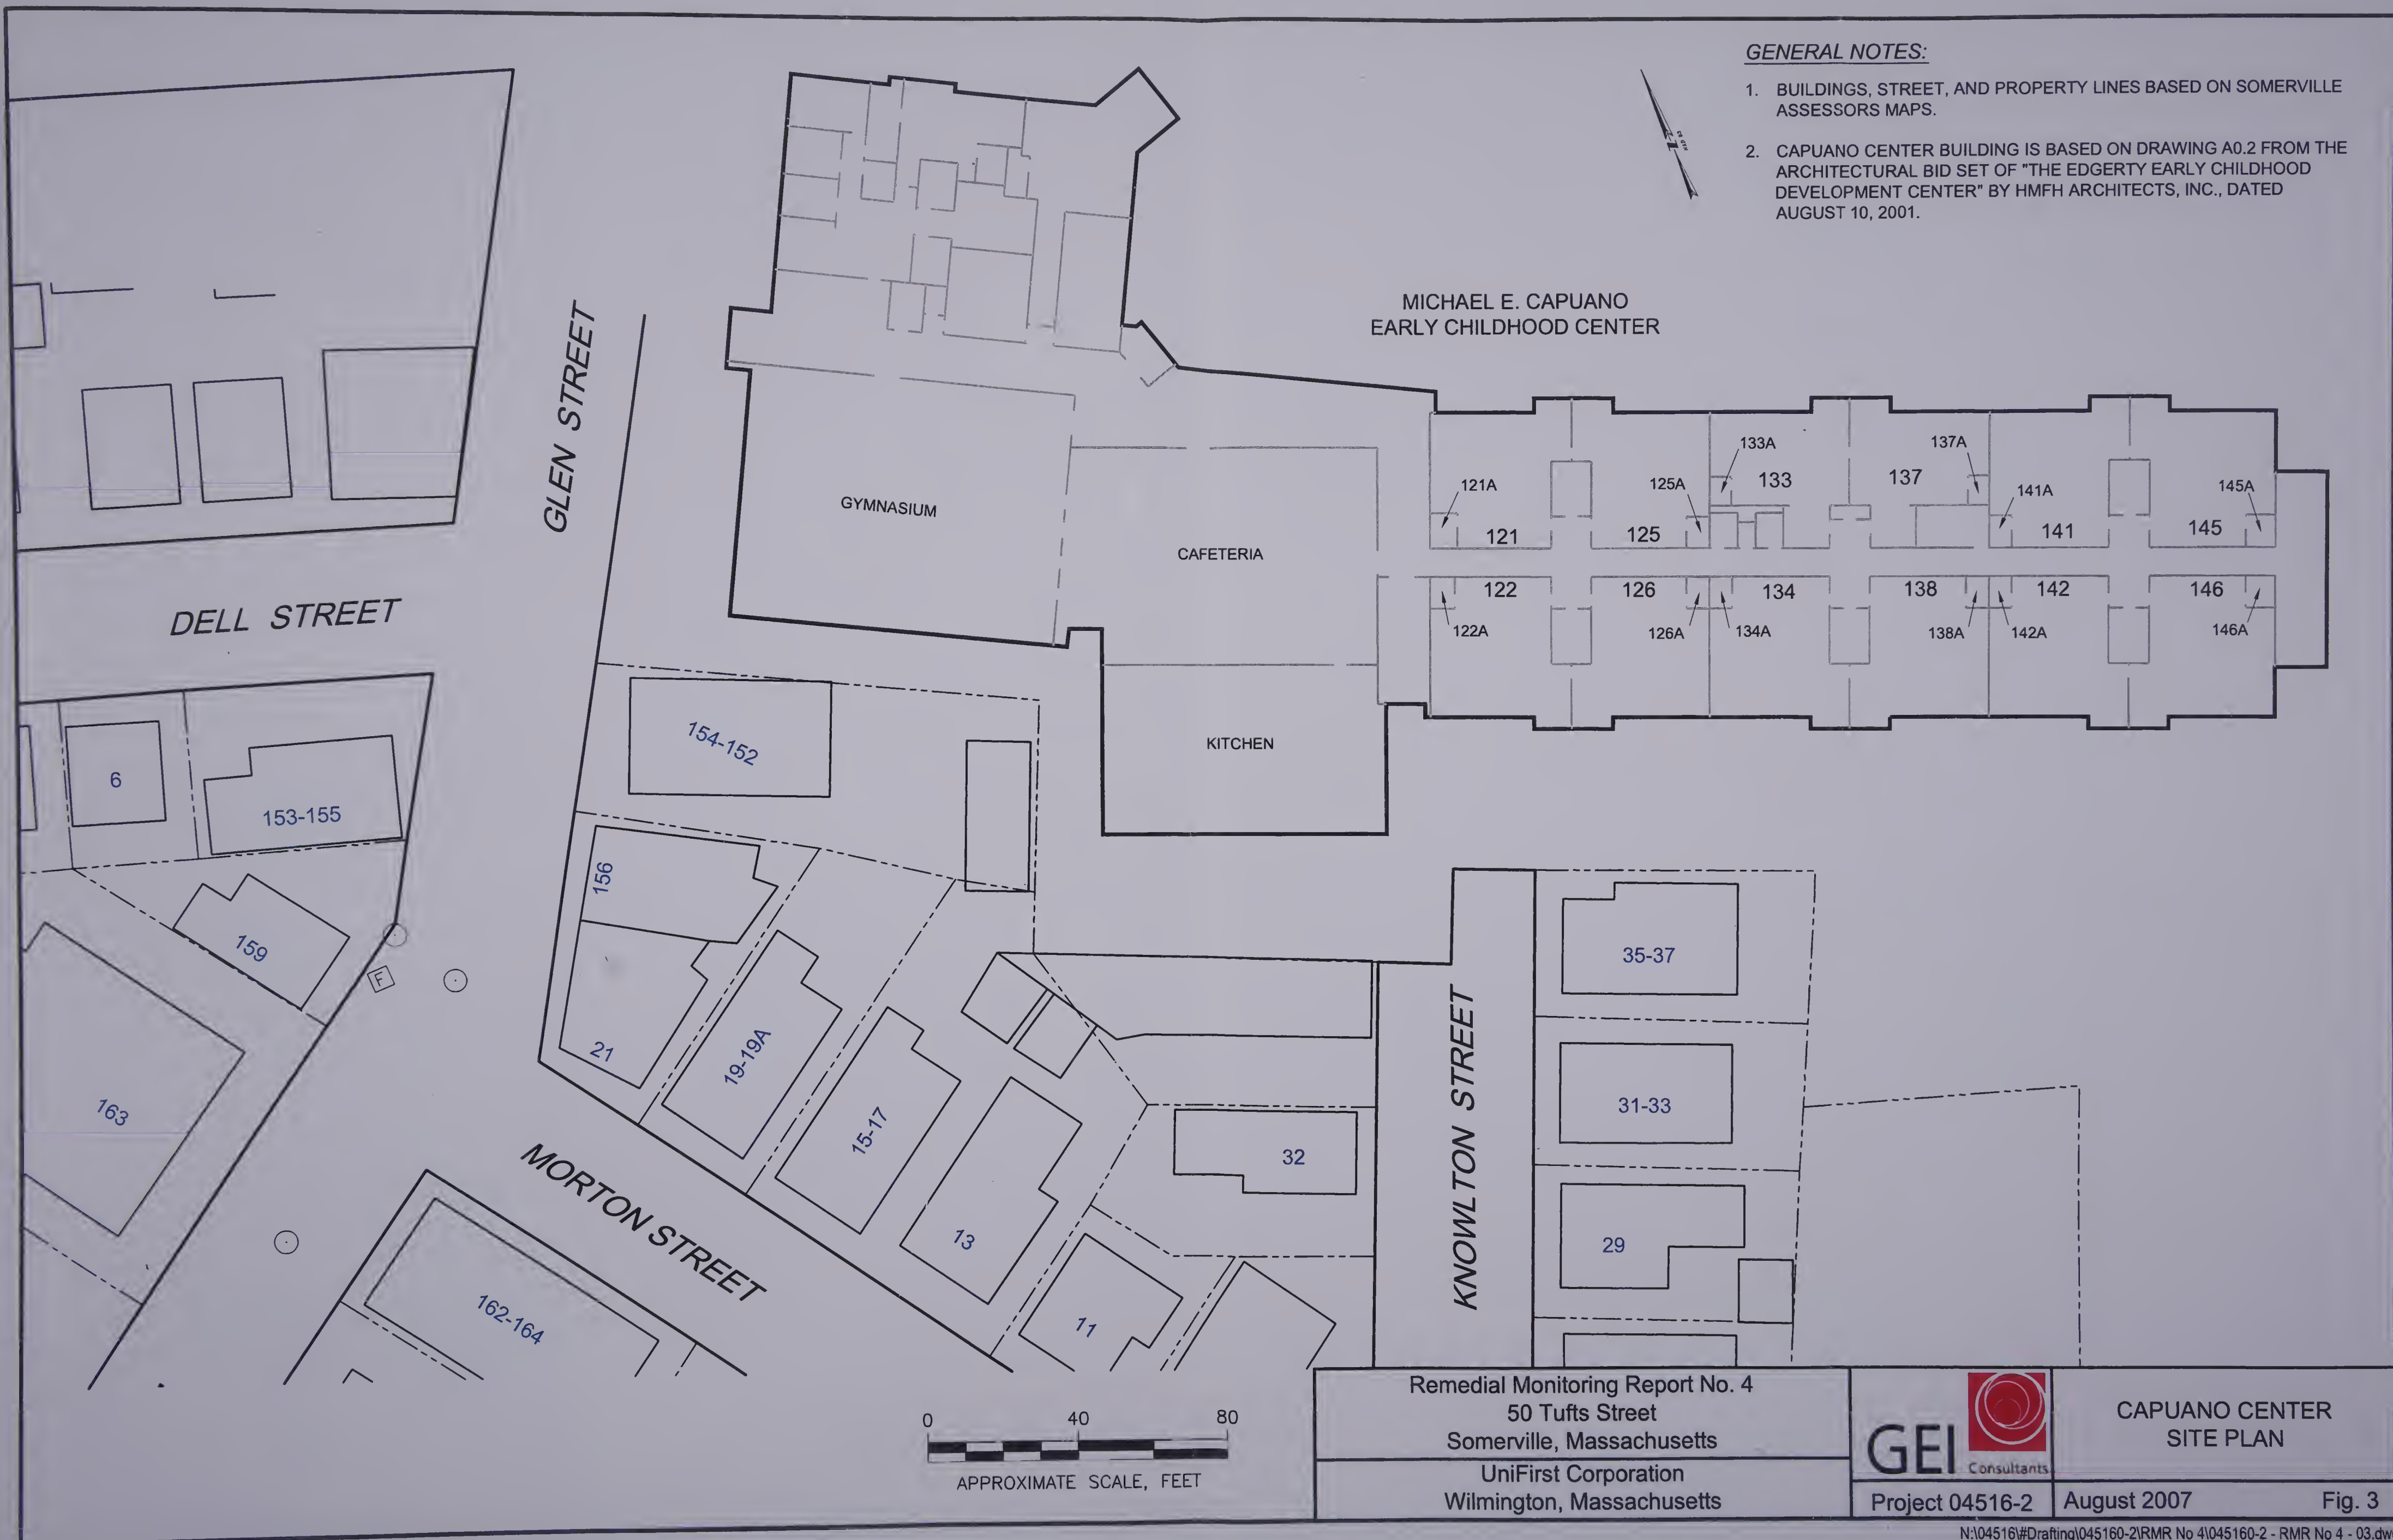
CAPUANO CENTER
 SITE PLAN

operated until the mechanical equipment can be moved to another suitable permanent location. Sub-slab soil gas monitoring points were installed inside the building at six locations to monitor the effectiveness of the SSDS. The six monitoring points were installed in the bathrooms of Classrooms 122, 126, 133, 137, 142 and 146. Figure 3 is the Center site plan.

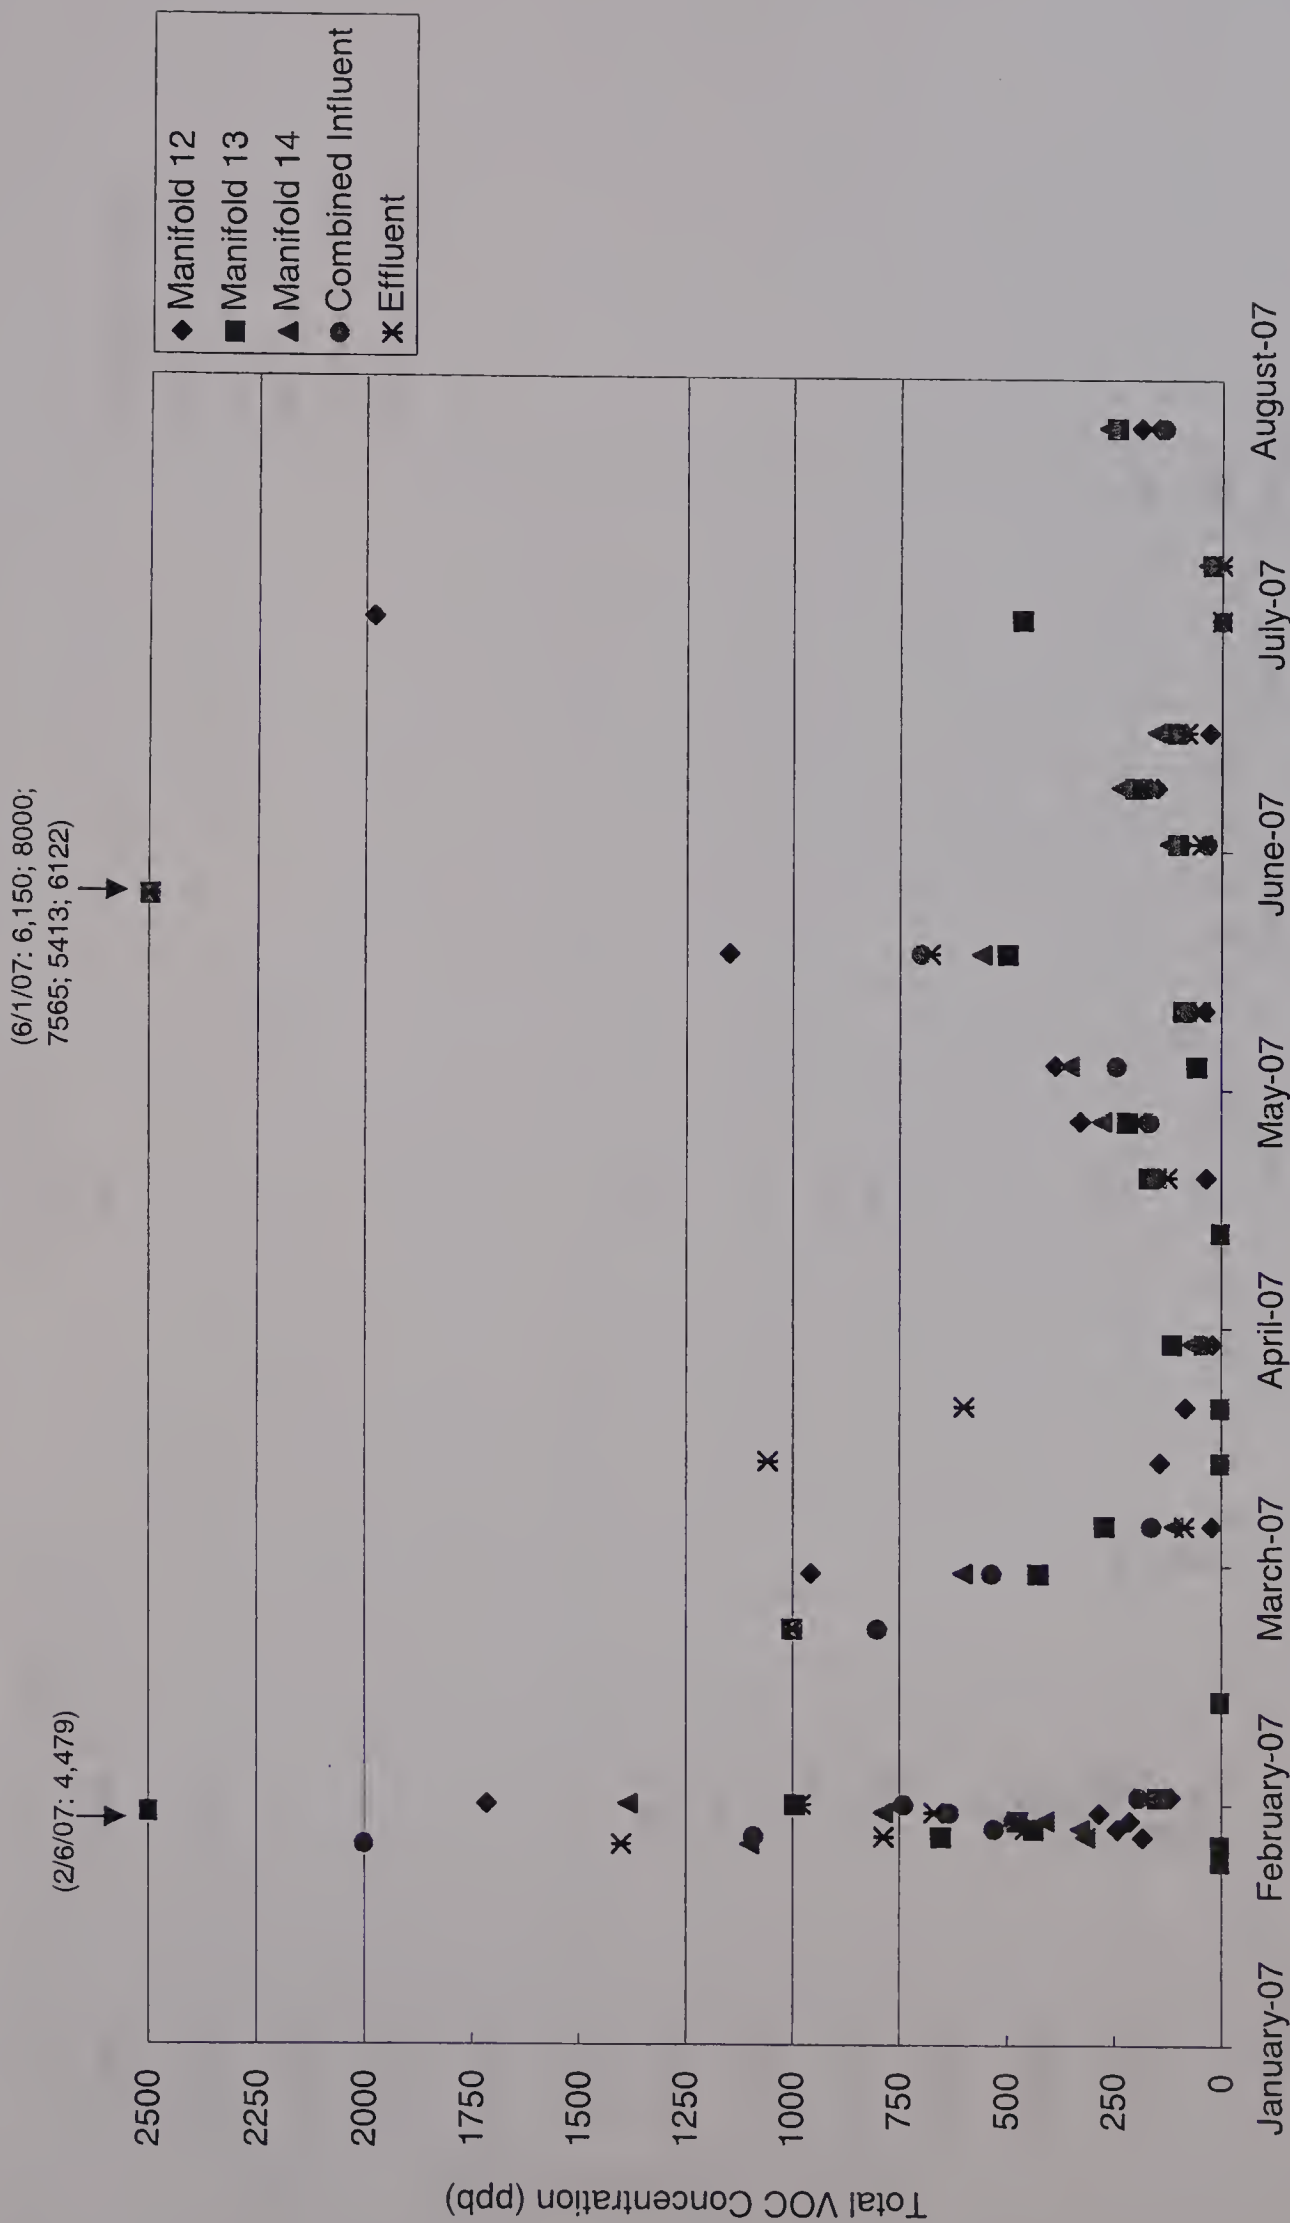
Total VOC Concentrations by PID at Blower Enclosure Sub-Slab Monitoring Points

Capuano Center
Somerville, MA

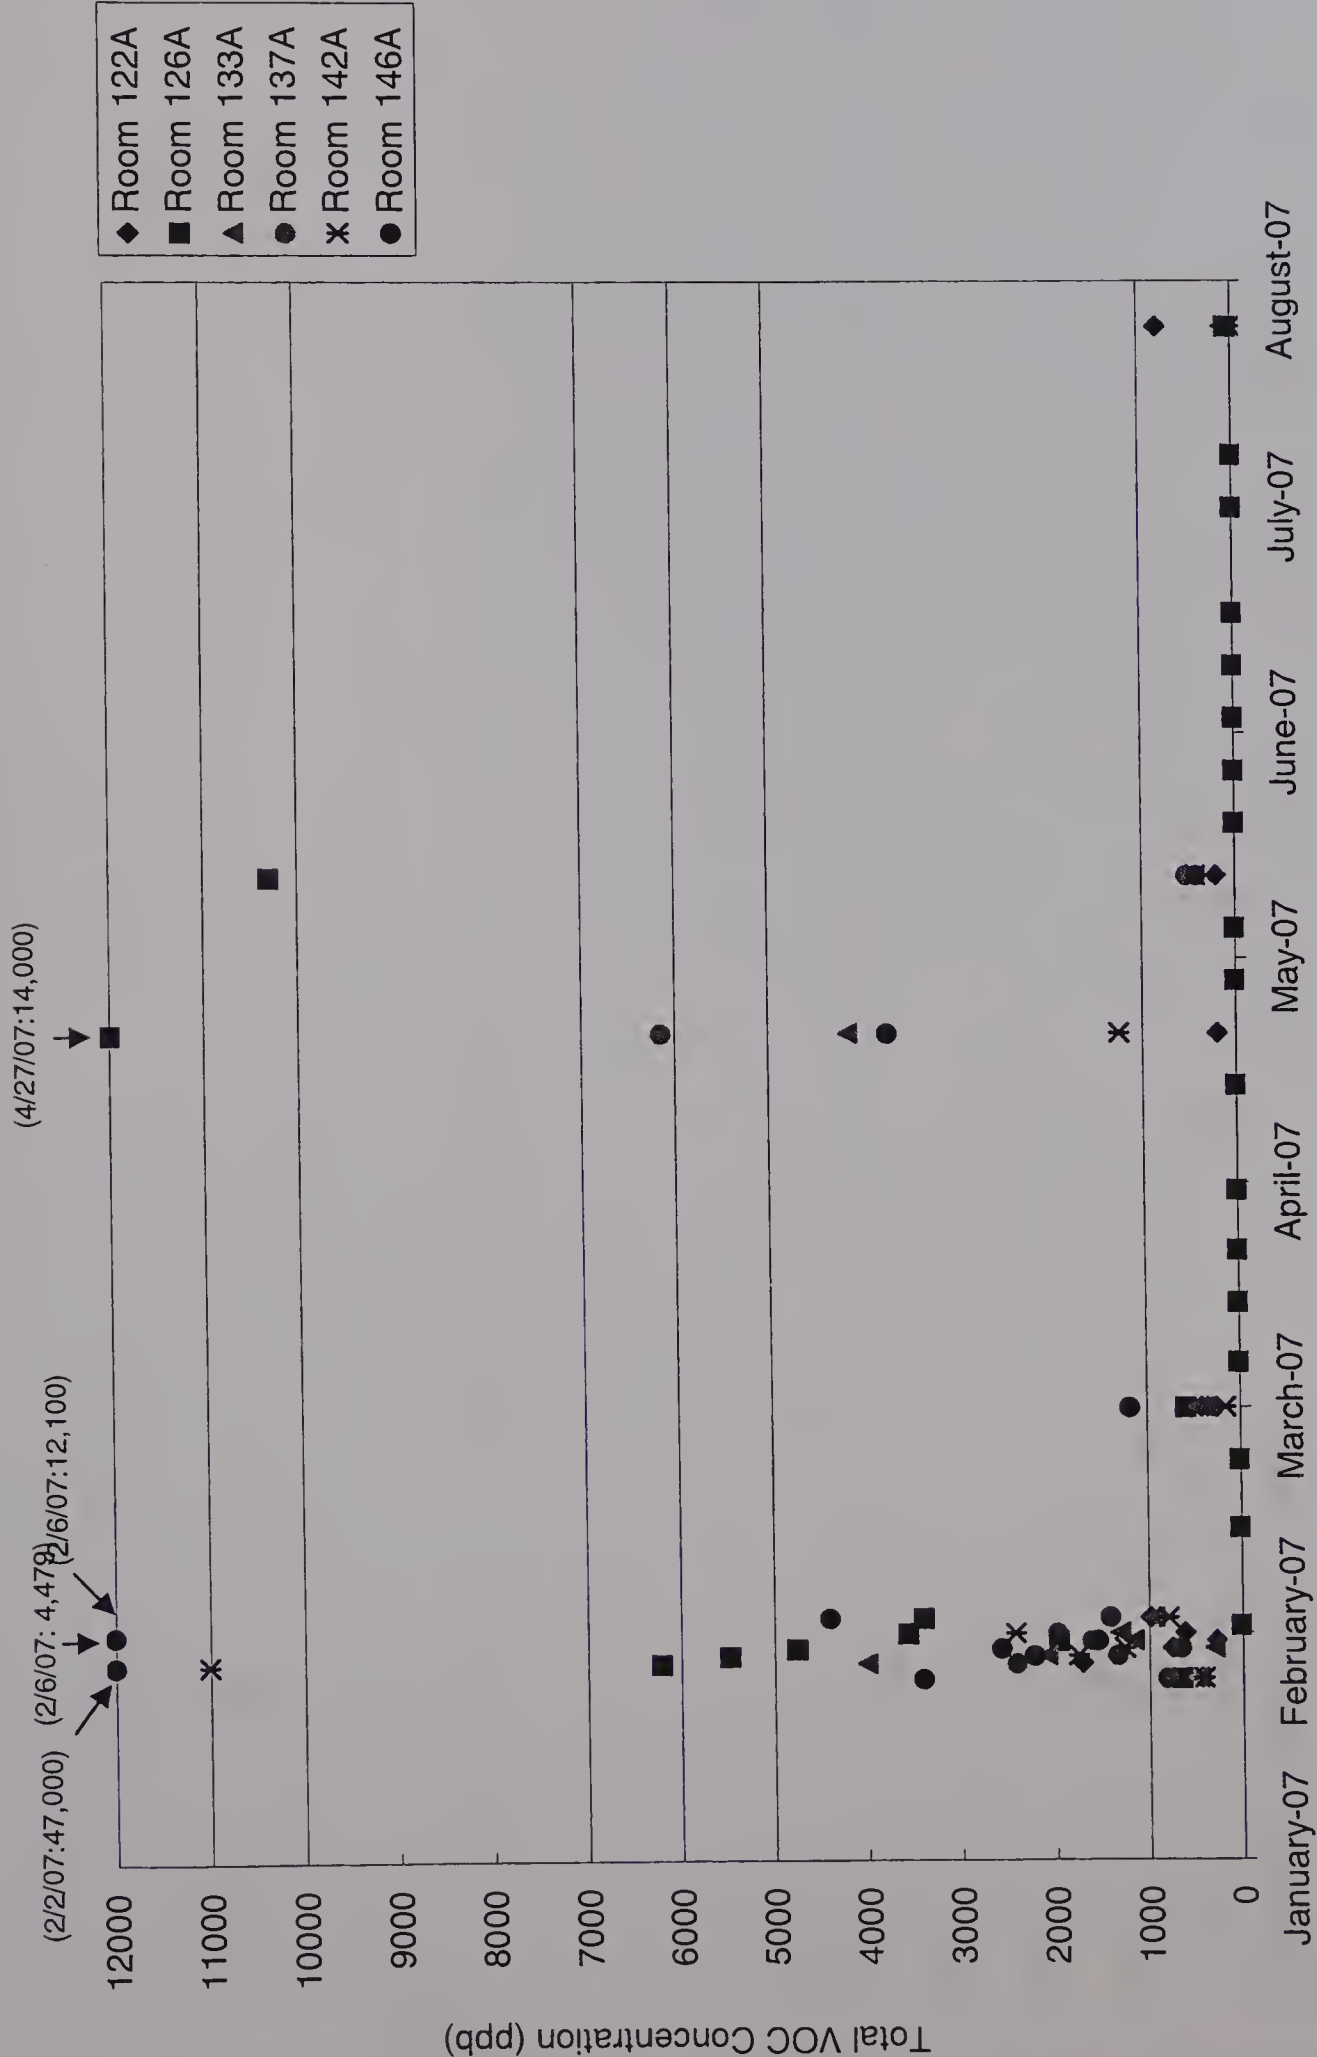
Graph 2

PID Monitoring Data: January 31, 2007 - July 31, 2007
Total VOC Concentrations by PID at Blower Interior Sub-Slab Monitoring Points
Capuano Center
Somerville, MA

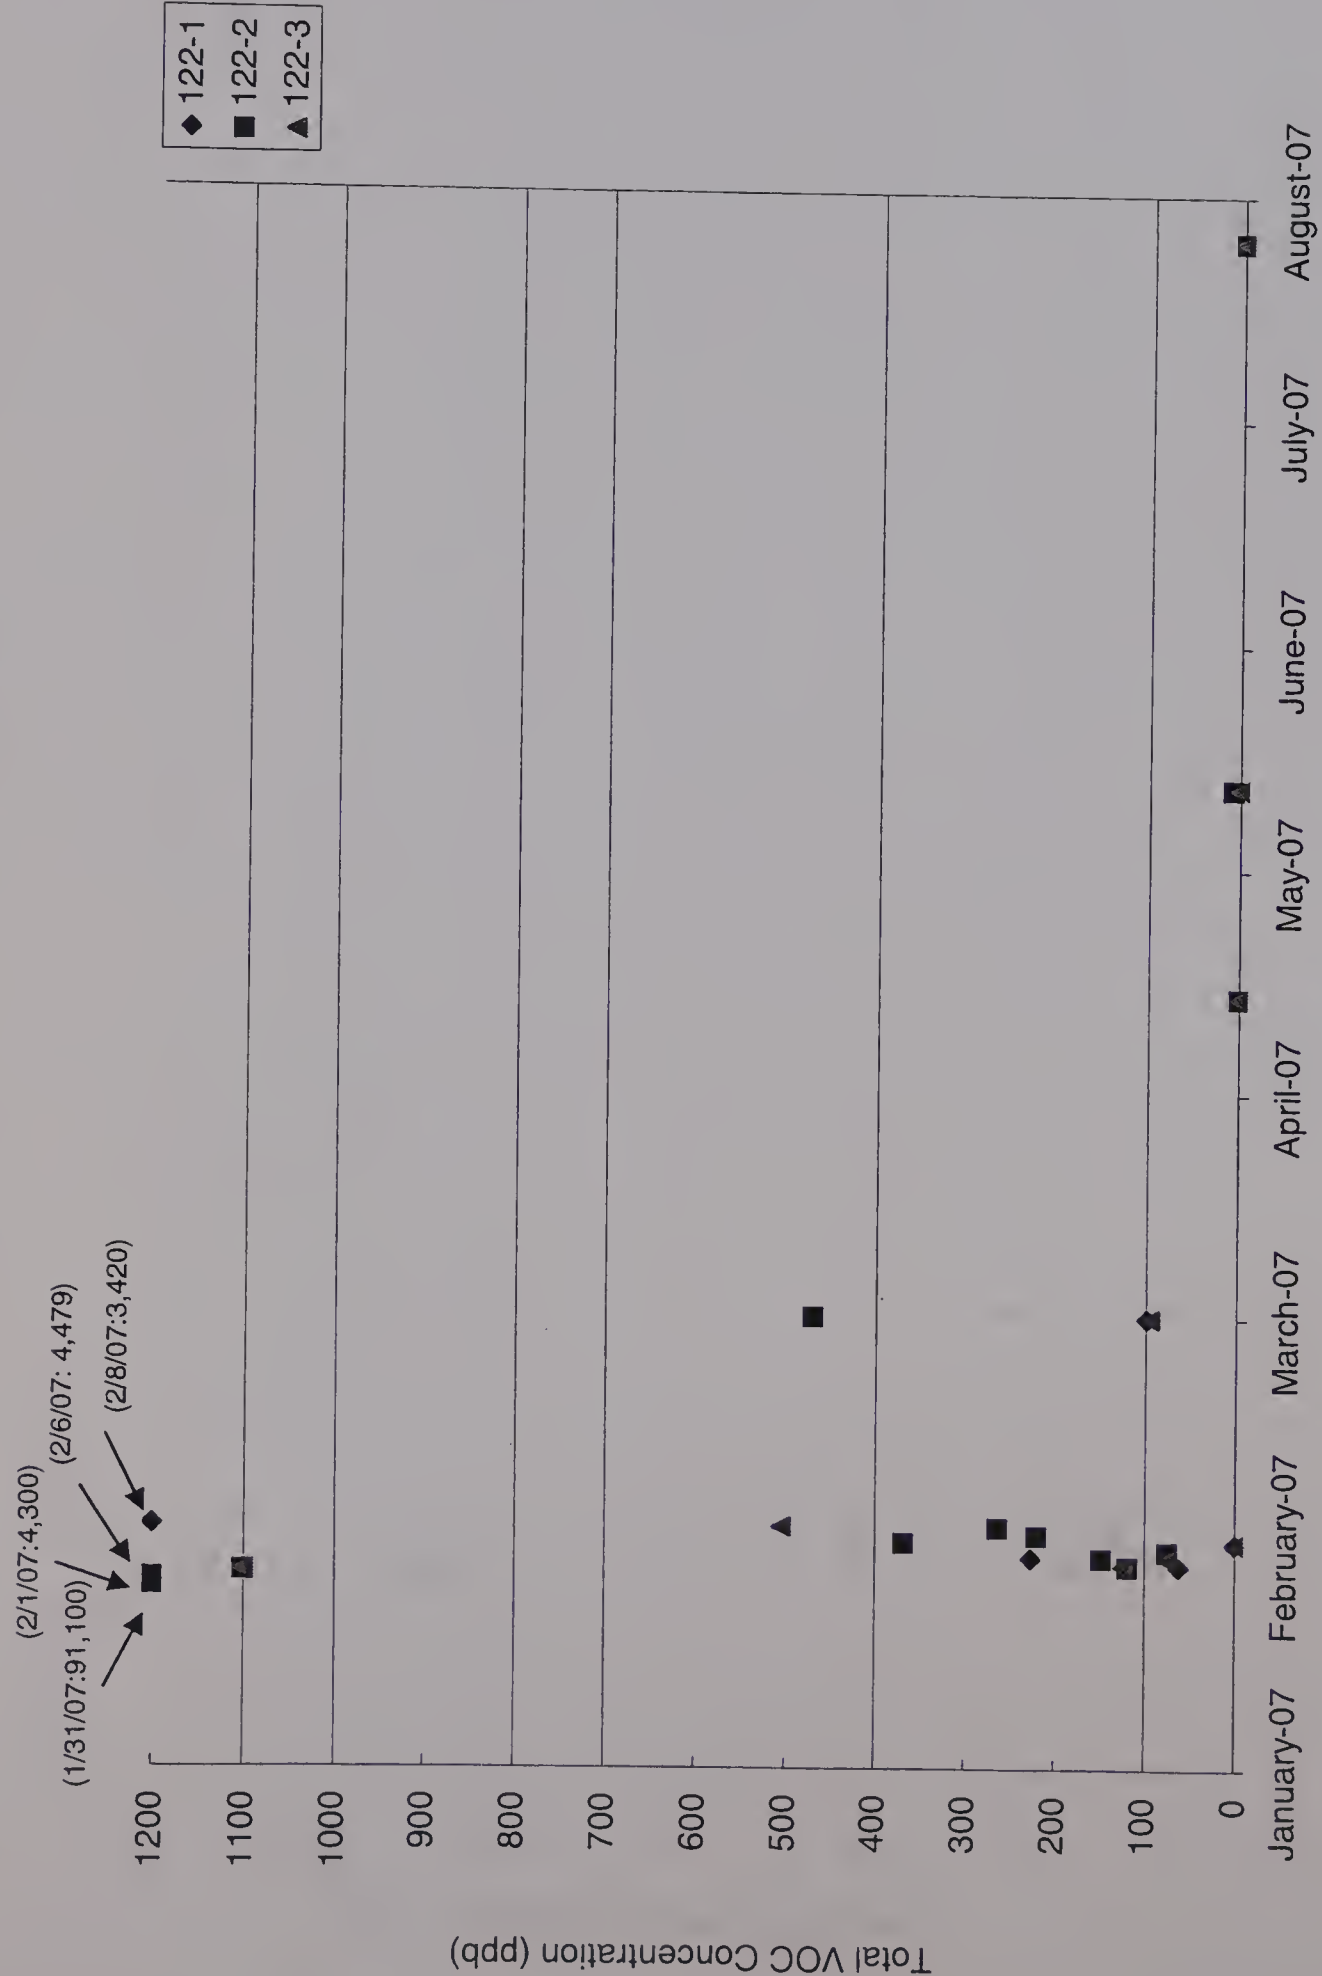
Graph 3

PID Monitoring Data: January 31, 2007 - July 31, 2007
Total VOC Concentrations by PID at Exterior Monitoring Points - Room 122
Capuano Center
Somerville, MA

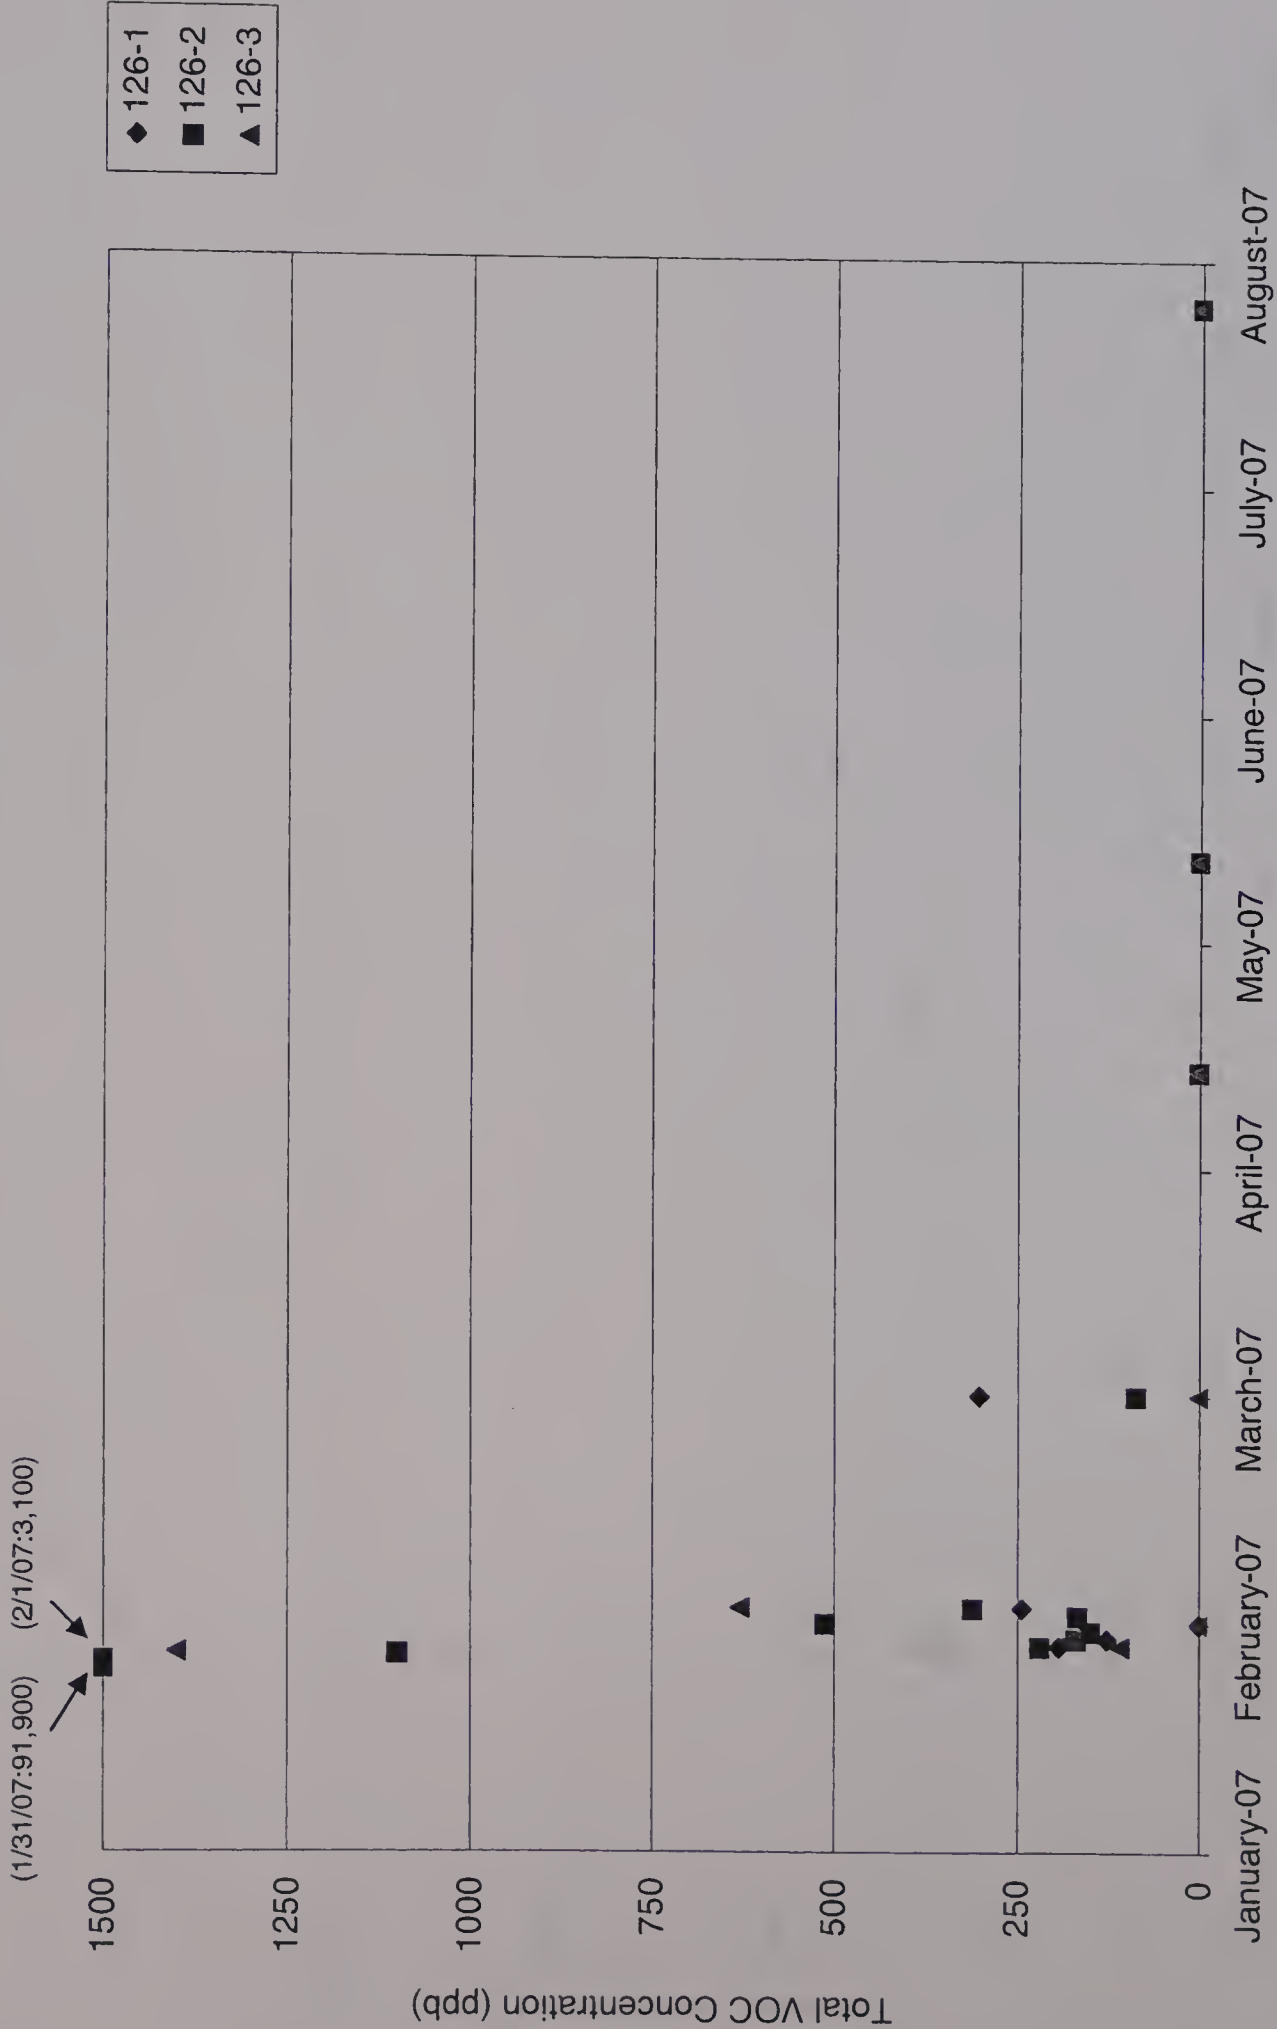
Graph 4

PID Monitoring Data: January 31, 2007 - July 31, 2007
Total VOC Concentrations by PID at Exterior Monitoring Points - Room 126
Capuano Center
Somerville, MA

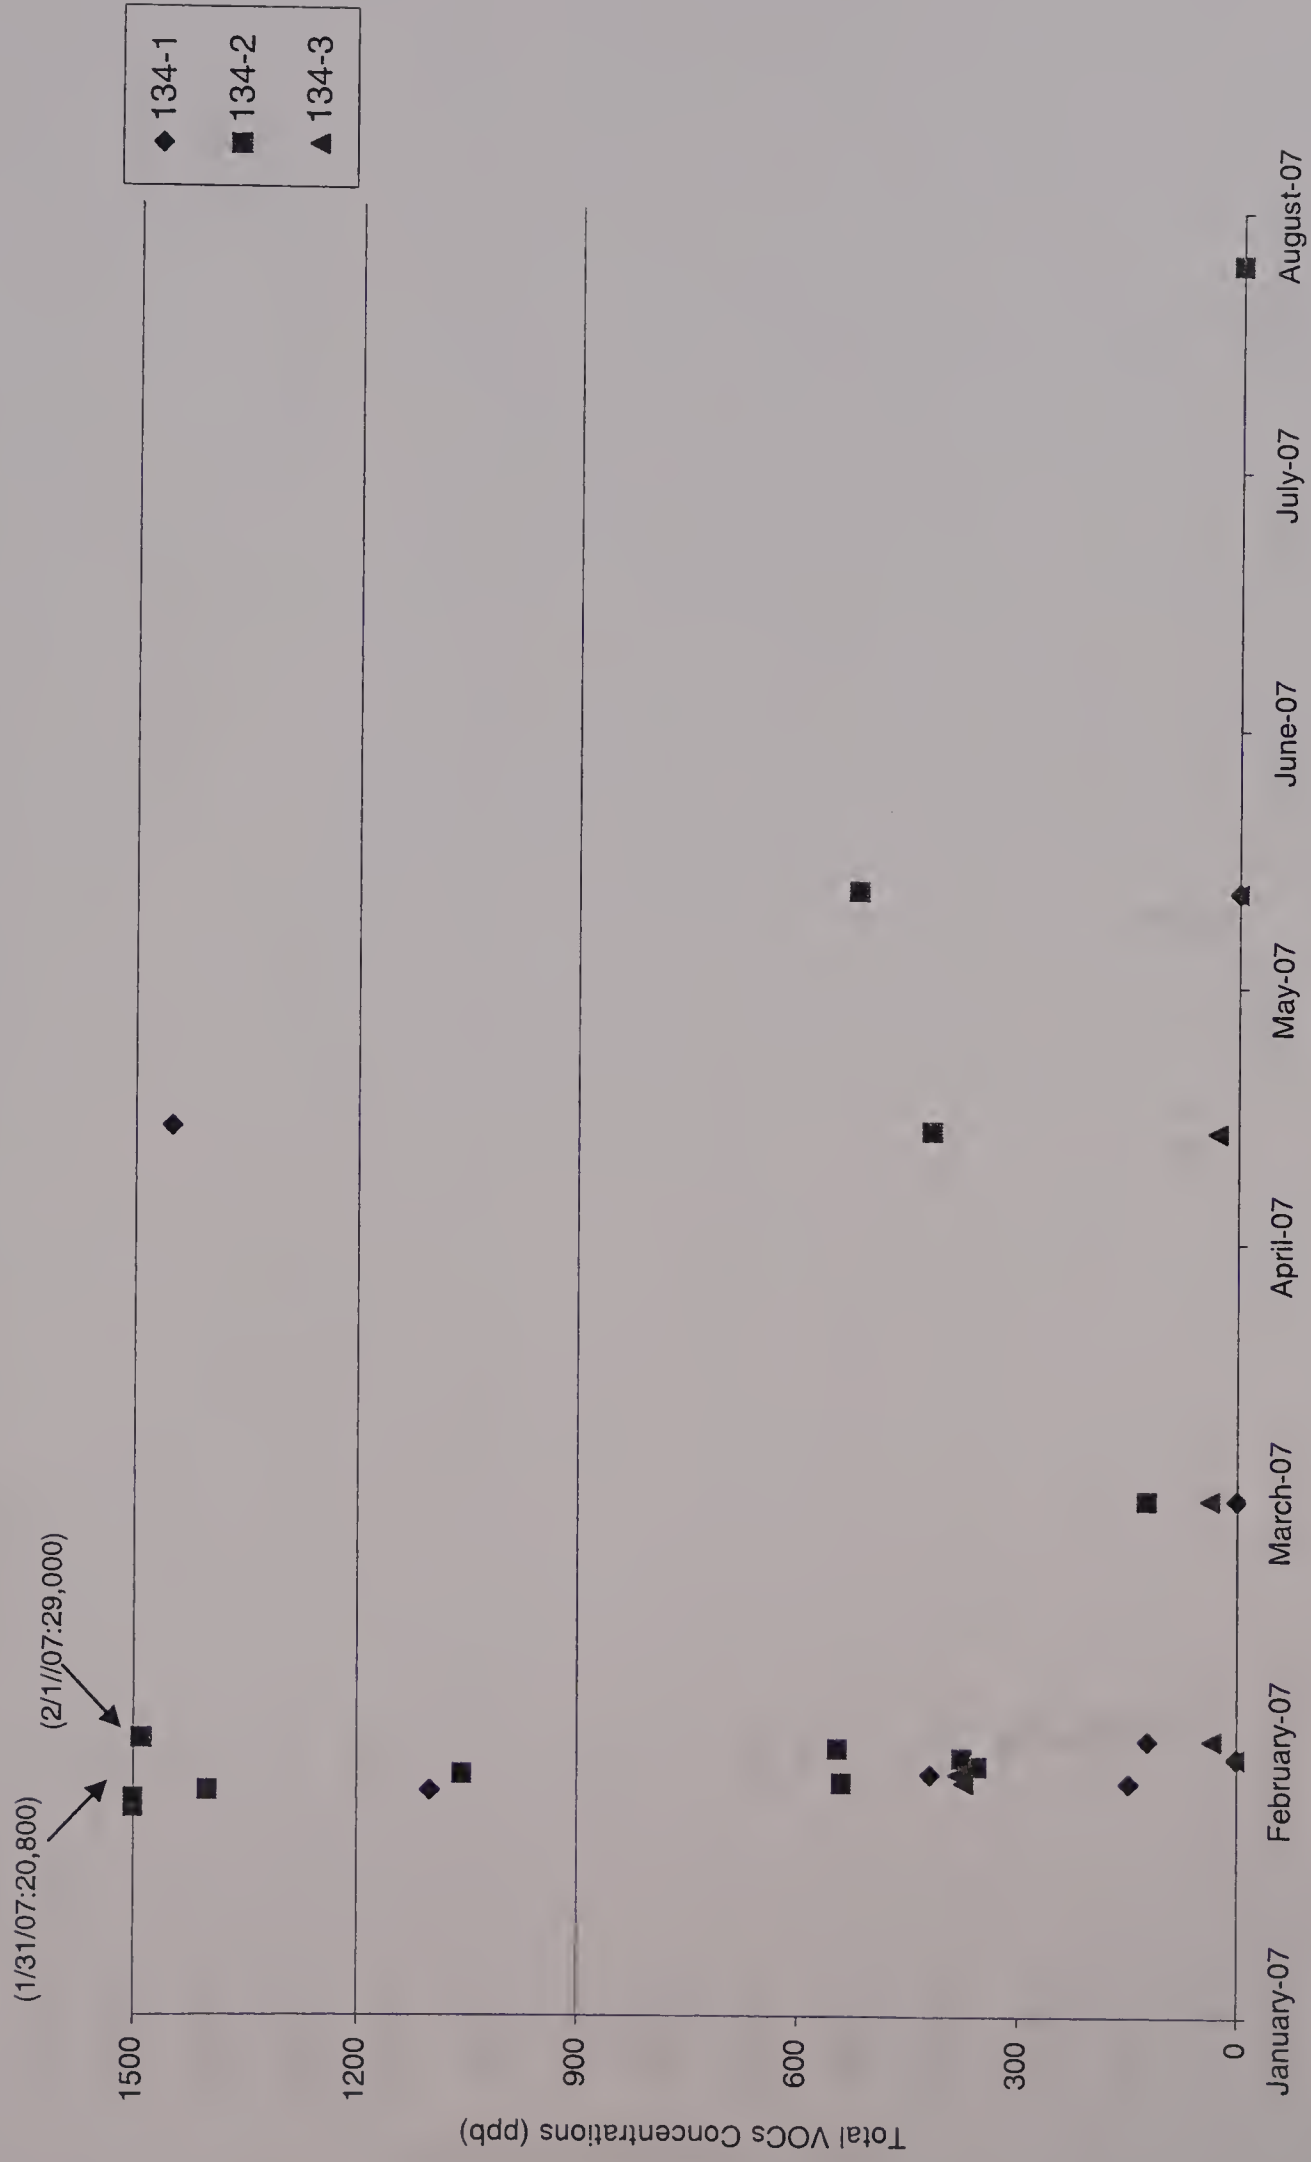
Graph 5

PID Monitoring Data: January 31, 2007 - July 31, 2007
Total VOC Concentrations by PID at Exterior Monitoring Points - Room 134
Capuano Center
Somerville, MA
